San Luis Obispo Council of Governments

Draft
Chorro Valley Trail Study
Existing Conditions, Opportunities and Constraints Report

March 2014

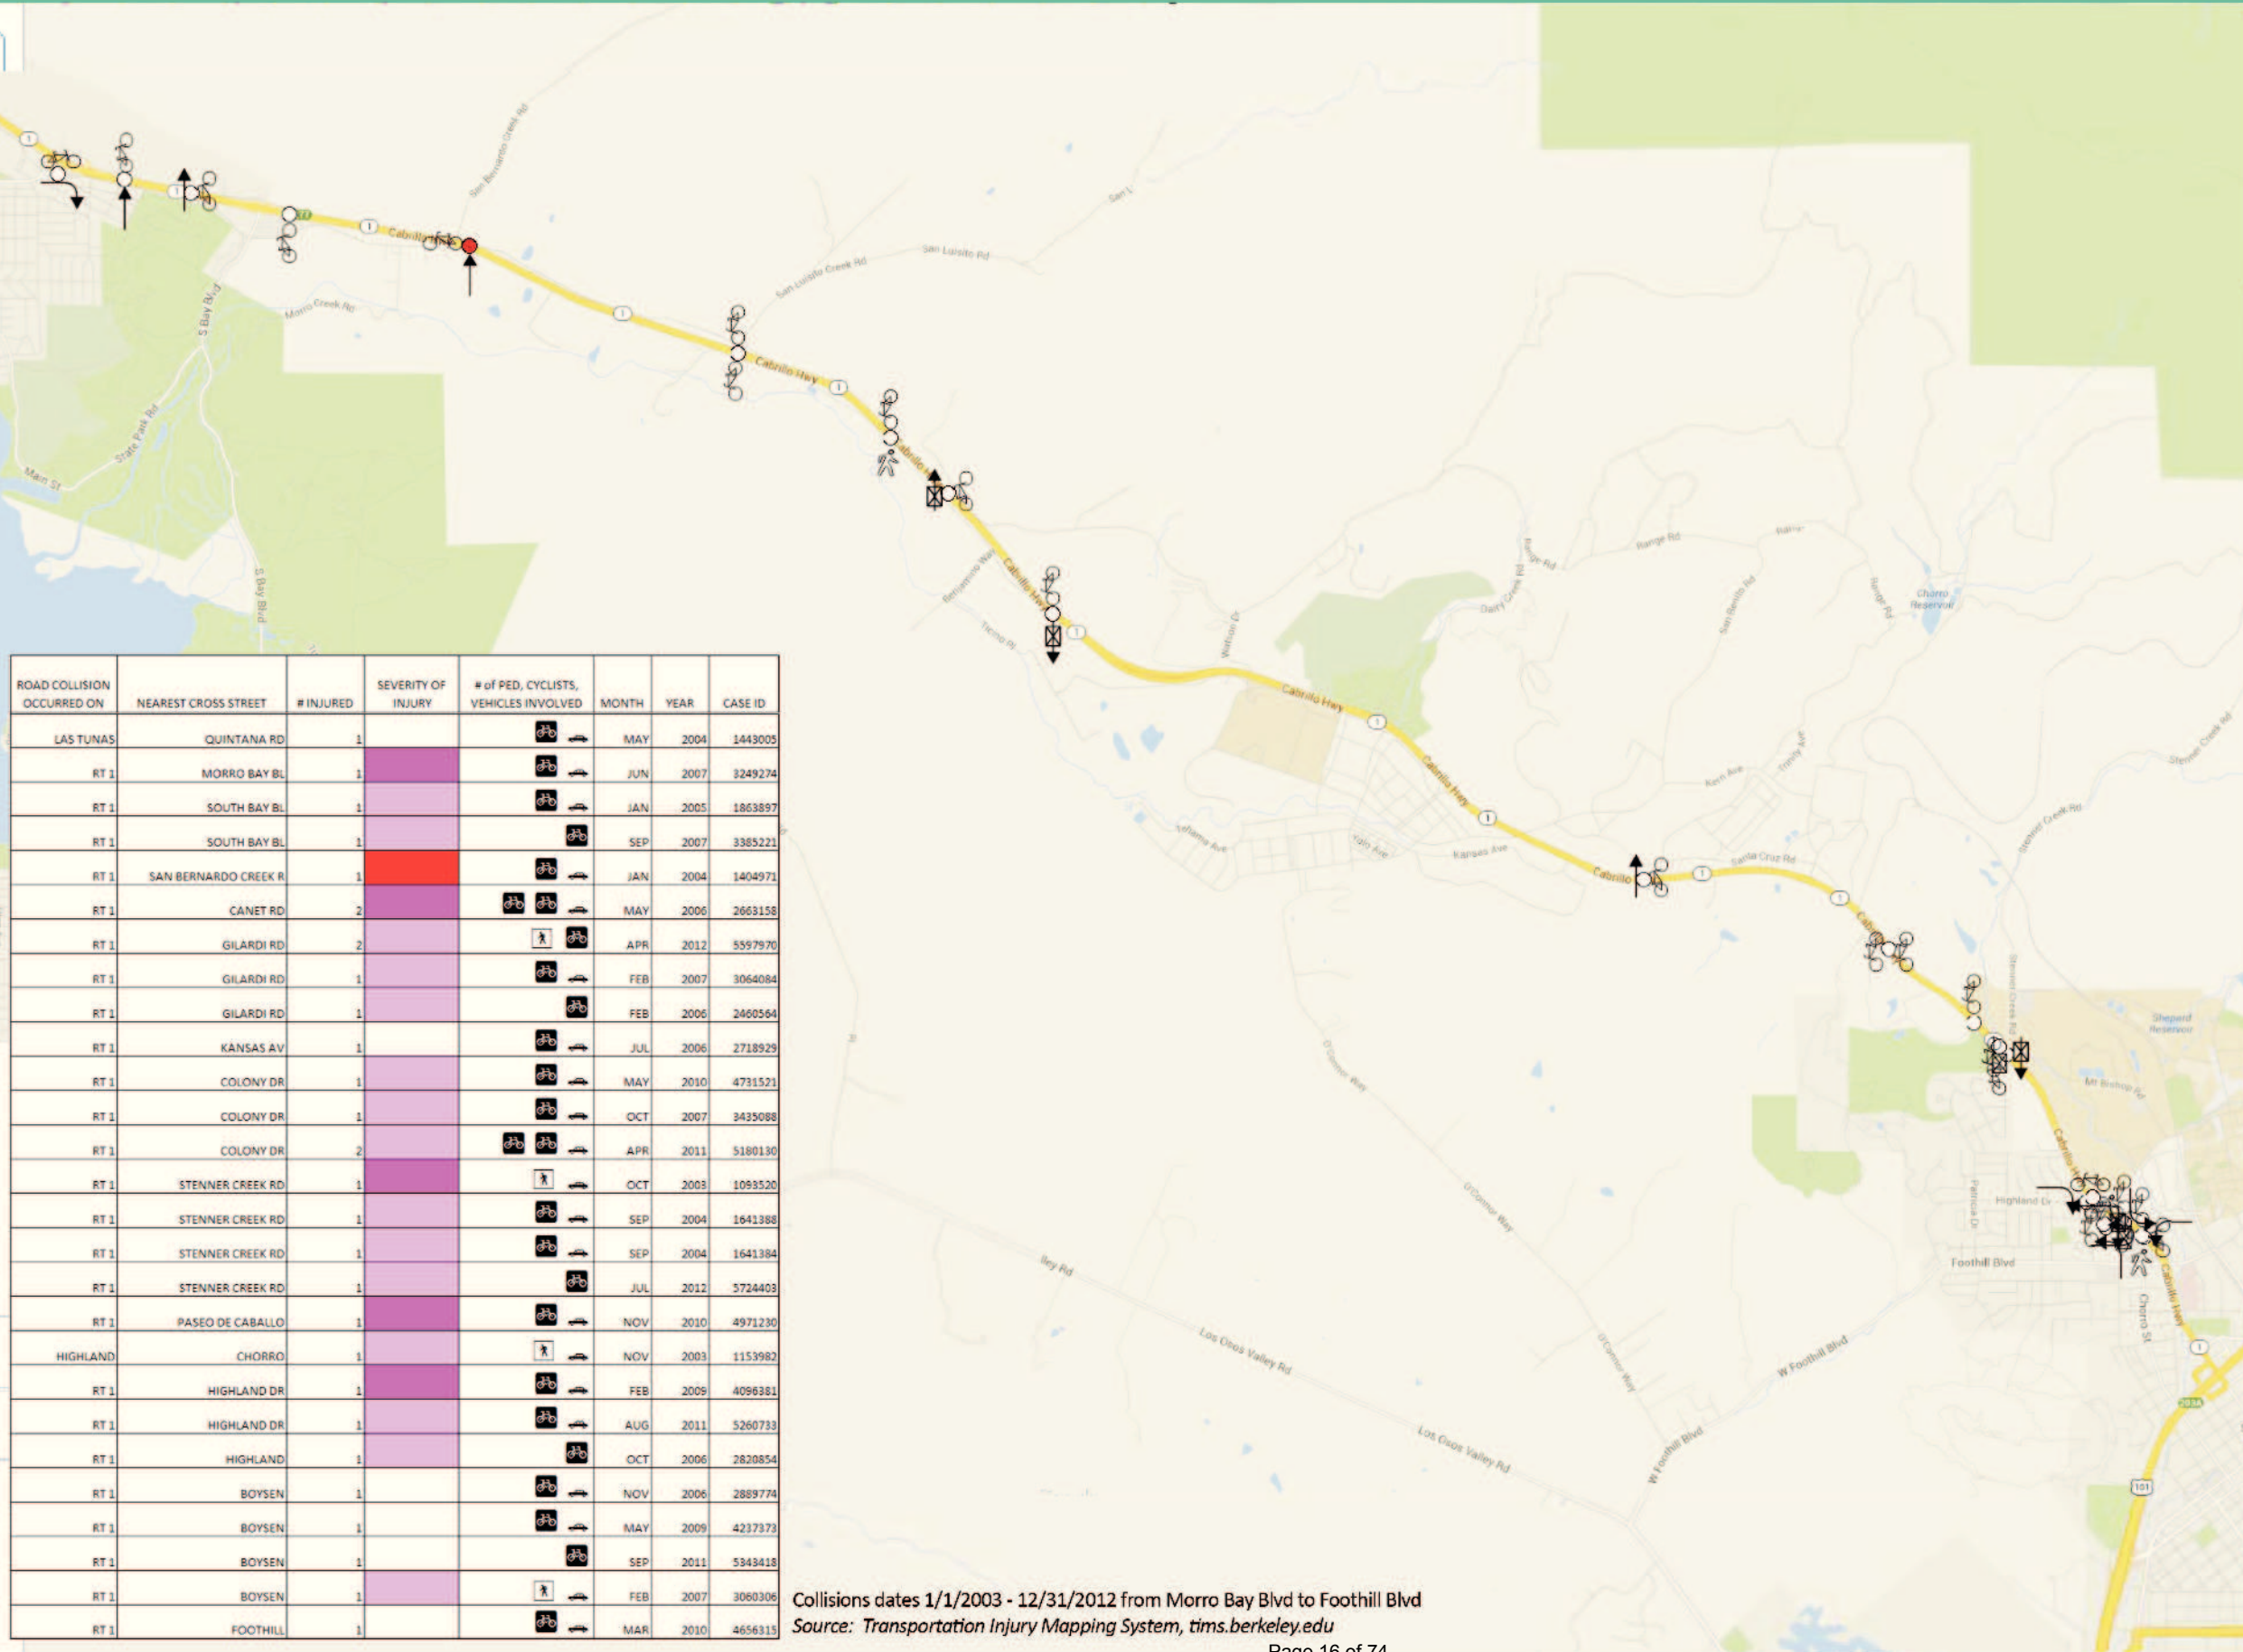
Trail Alignments
FIGURE 2 BIKE/PED COLLISIONS

Although other stretches of Highway 1 present significant challenges such as limited line of sight visibility, limited shoulder area, and steeper grades, the ride between Morro Bay and San Luis Obispo is currently recommended for use only by experienced road cyclists, because of safety concerns and other factors. There have been at least two fatal bicycle accidents along the northern portion of the route (near Morro Bay Boulevard), in May and September 2013. Figure 2 provides a summary of bicycle and pedestrian accidents within the study area, as drawn from the Transportation Injury Mapping System, (TIMS) maintained by the Safe Transportation Research and Education Center (SafeTREC) at UC Berkeley. The TIMS database covers the time period from January 2003 to December 2012. In addition to the two bicycle fatalities listed above, there was a bicycle fatality on Highway 1 near San Bernardo Creek Road in January 25, 2004. Also of note is the cluster of non-fatal bicycle-automobile collisions near the intersection of Highland Drive and Santa Rosa Avenue.

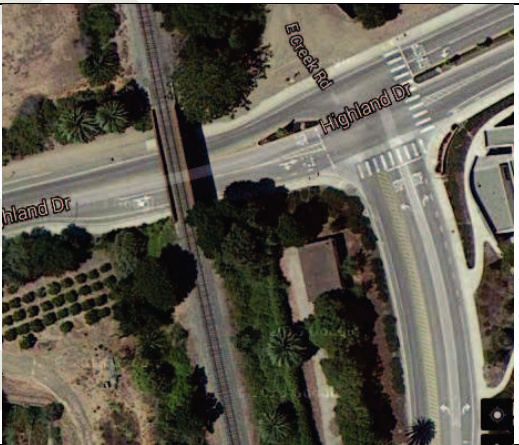
Segment	Location	Description	
1A	Highland at California	Stop signs, striped crosswalk and partial sidewalks along north and east sides

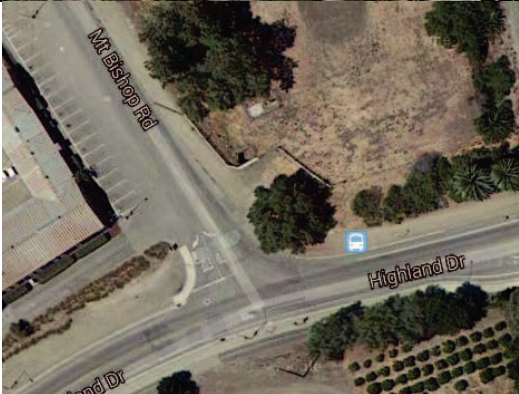
Highland at Mount Bishop	Stop sign at northwest corner only, no crosswalk to Class 1 path; small discontinuous sidewalk

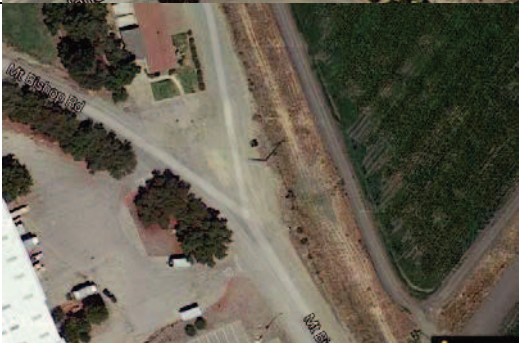
Mount Bishop Road at Unnamed Road	No sidewalks, crosswalks or stop signs

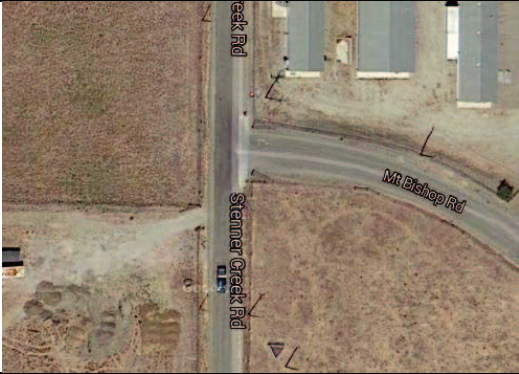
Segment	Location	Description	
	Mount Bishop at Stenner Creek Road	Stop sign at NE corner, no sidewalks, crosswalks or striping

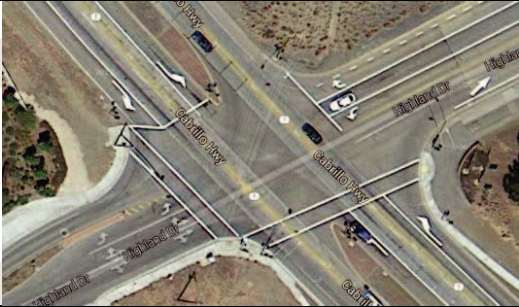
1B	Santa Rosa (Hwy. 1) At Highland	Signalized intersection with discontinuous sidewalks, crosswalks on south and west side only

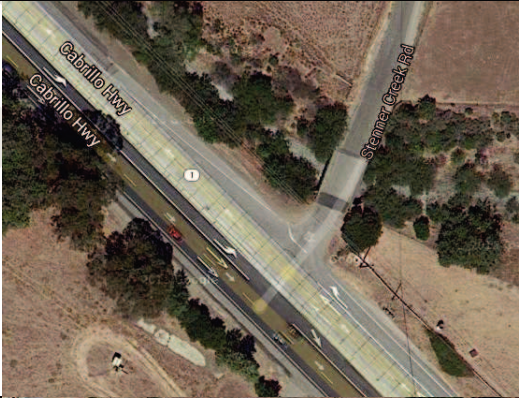
Highland at Stenner Creek Road	Left turn and right turn lanes into Stenner Creek Road, stop sign NW corner. No bike/ped facilities

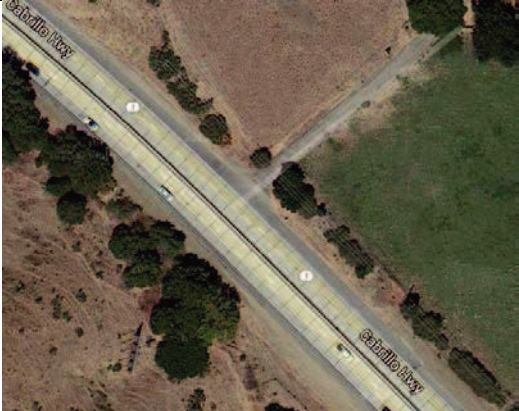
1B/1C	Hwy. 1 at Cal Poly farm road	Uncontrolled

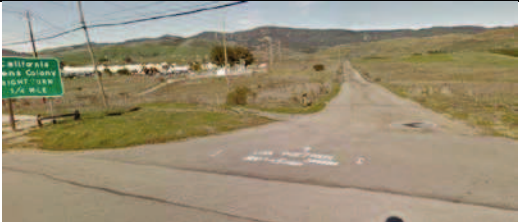
Segment	Location	Description	
2B	Hwy. 1 at Cal Poly access road	Uncontrolled

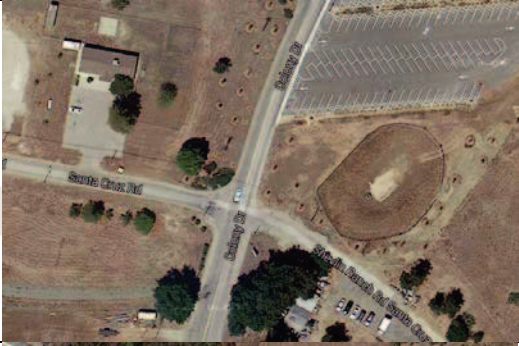
3A	Colony Drive at Santa Cruz Road	Stop sign at SW corner only, no sidewalks or crosswalks

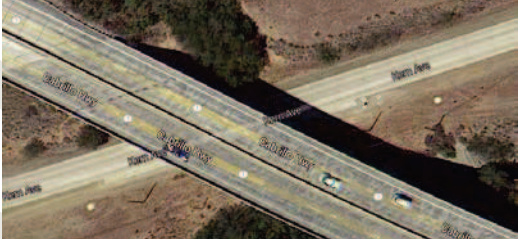
3A	Kern Avenue (Camp SLO)	Kern Avenue crosses under Hwy. 1 within Camp SLO secure area; no stop signs

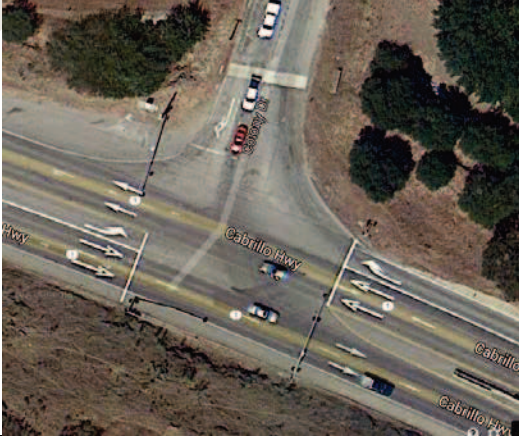
3B	Hwy 1 at Colony Drive	Signalized intersection, left and right turn lanes; no sidewalks, crosswalks or bike/ped facilities

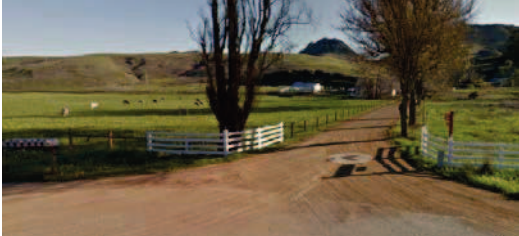
Hwy. 1 at Mainini Ranch Road	Uncontrolled, private

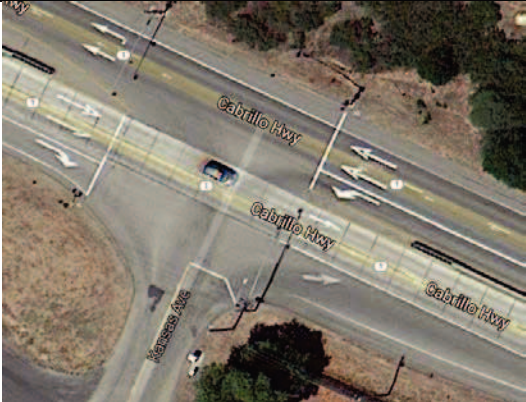
Segment	Location	Description	
	Hwy. 1 at Kansas Avenue (county facilities)	Signalized intersection, left and right turn lanes; merge lanes; no sidewalks, crosswalks or bike/ped facilities

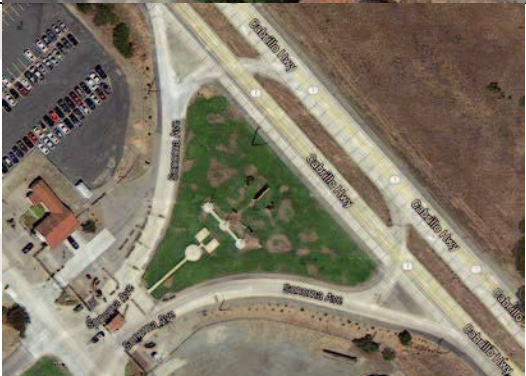
Hwy 1 at Sonoma Ave. (Camp SLO entry)	Dual entry with slip ingress/egress and turn lanes E/W; no bike/ped/crosswalks; security barriers

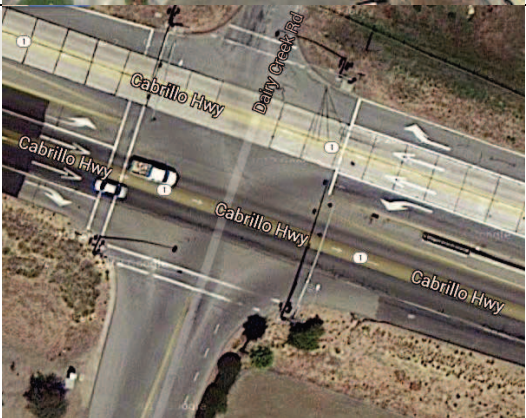
4A, 4B	Hwy 1 at Hollister Avenue (entrance to Cuesta College, El Chorro Regional Park)	Signalized intersection, left and right turn lanes; merge lanes; no sidewalks; crosswalks on N/W/S sides; no bike/ped facilities

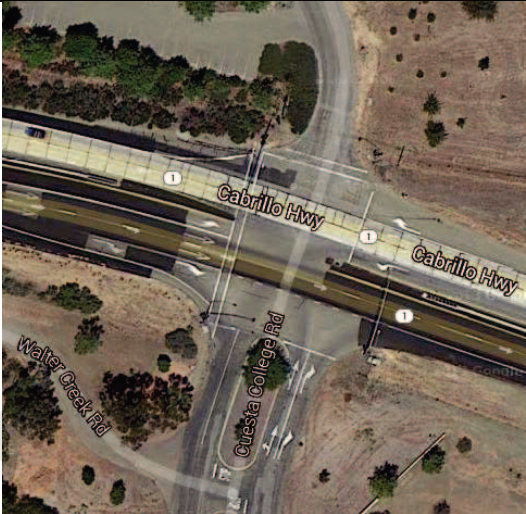
Segment	Location	Description	
4A, 4B	Hwy. 1 at Education Drive, Watson Drive (main Cuesta College entrance)	Signalized intersection, left and right turn lanes; merge lanes; no sidewalks; crosswalks on N/W/S sides; no bike/ped facilities

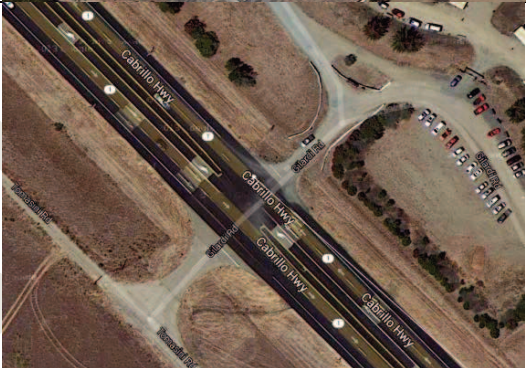
5A, 5B	Hwy. 1 at Gilardi Road	Stop signs at minor roads; no bike/ped facilities

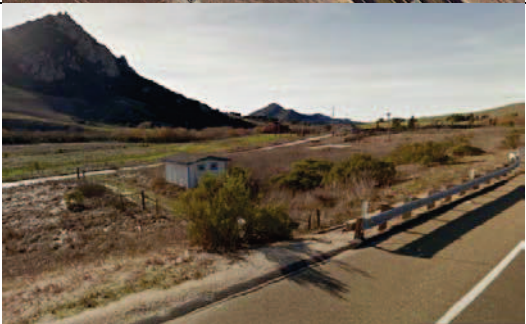
6A, 6B	Hwy 1 Equipment Under-crossing Hwy. 1 DFW	Within Chorro Creek Ecological Reserve; CA DFW

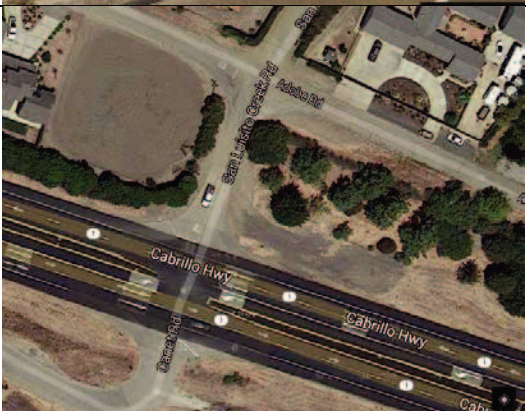
6A	San Luisito Creek Road at Adobe Road	Stop signs on Adobe Road only; no bike/ped facilities

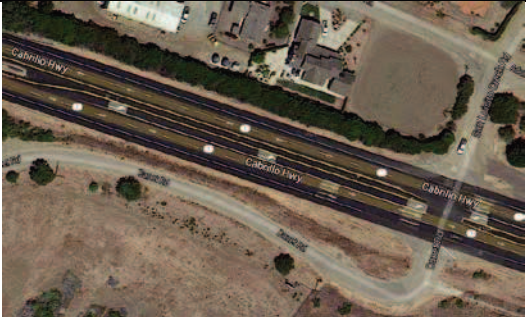
Segment	Location	Description	
6A, 6B	Hwy. 1 at San Luisito Creek Road and Canet Road	Stop signs on minor roads; left turn lanes; no bike/ped facilities

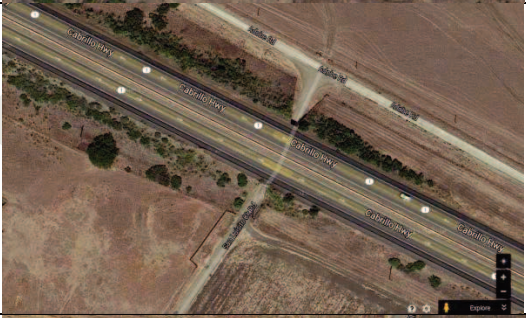
6A, 6B	Hwy 1 Equipment Under-crossing Hwy. 1 (Jones)	Equipment access to Jones property under Hwy. 1; Caltrans ROW extends to toe of slope on S/S

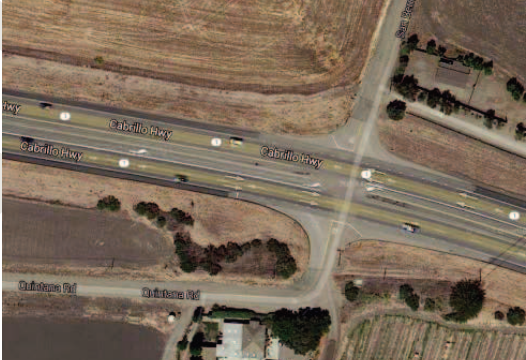
7A, 7B	Hwy. 1 at San Bernardo Creek Road and Quintana Road	Stop signs on minor roads; Left turn pockets; no bike/ped facilities

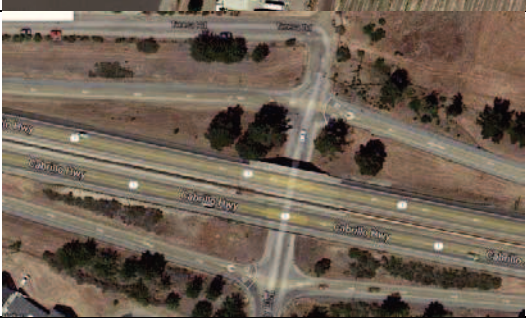
7A	Highway 1 at South Bay Blvd.	Hwy interchange, South Bay Blvd. crosses under Hwy; stop signs at on/offramps; no sidewalks, crosswalks or bike/ped facilities

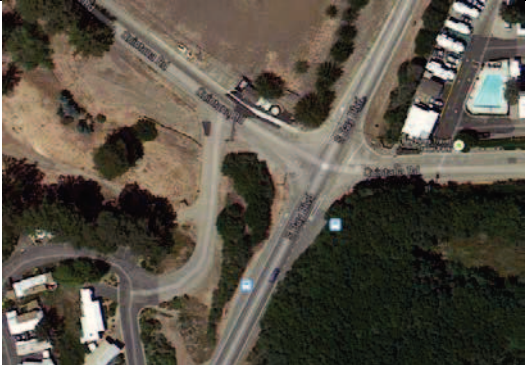
Segment	Location	Description	
7B	South Bay Blvd. at Quintana Road	Street layout accommodates high speed turns onto Quintana; bus stops on South Bay Blvd., but no crosswalks, sidewalks or bike/ped facilities. Quintana Road to the west is striped for Class II bike lanes.

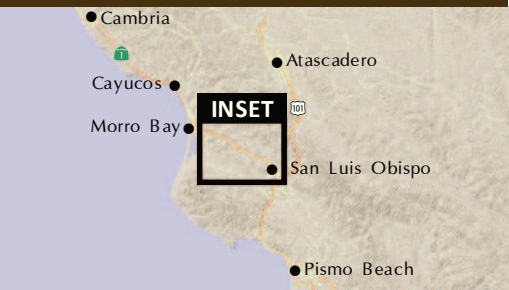
Trail Alignments
FIGURE 3 AGRICULTURAL RESOURCES

As shown by Figure 3, the upland portions of the Chorro Valley consist primarily of grazing lands. Pockets of important farmland exist along Chorro Creek, approximately between its confluences with San Luisito Creek and San Bernardo Creek, and along Stenner Creek within Cal Poly. To the west of San Luisito Creek Road, Alignments A and B also approach the boundaries of lands under Williamson Act contract to preserve agricultural use.

In addition, as indicated by Figure 3, if Alignment B is constructed within private farmland in Segments 6 and 7, it could conflict with existing Williamson Act contracts. According to the County's *Rules of Procedure to Implement the California Land Conservation Act of 1965* (also referred to as the Williamson Act), neither passive recreation nor outdoor sports/recreation are compatible uses on agricultural lands under Williamson Act contract. However, the proposed Chorro Valley Trail would

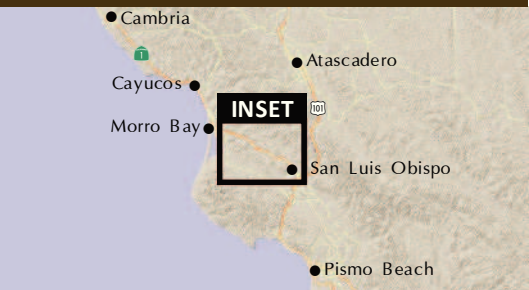
Trail Alignments FIGURE 4 BIOLOGICAL RESOURCES

Figure 4 provides an overview of biological resources within or near the study area, including coast live oak woodlands, wetlands, critical habitat, and occurrences of special-status species. These resources are discussed in greater detail below.

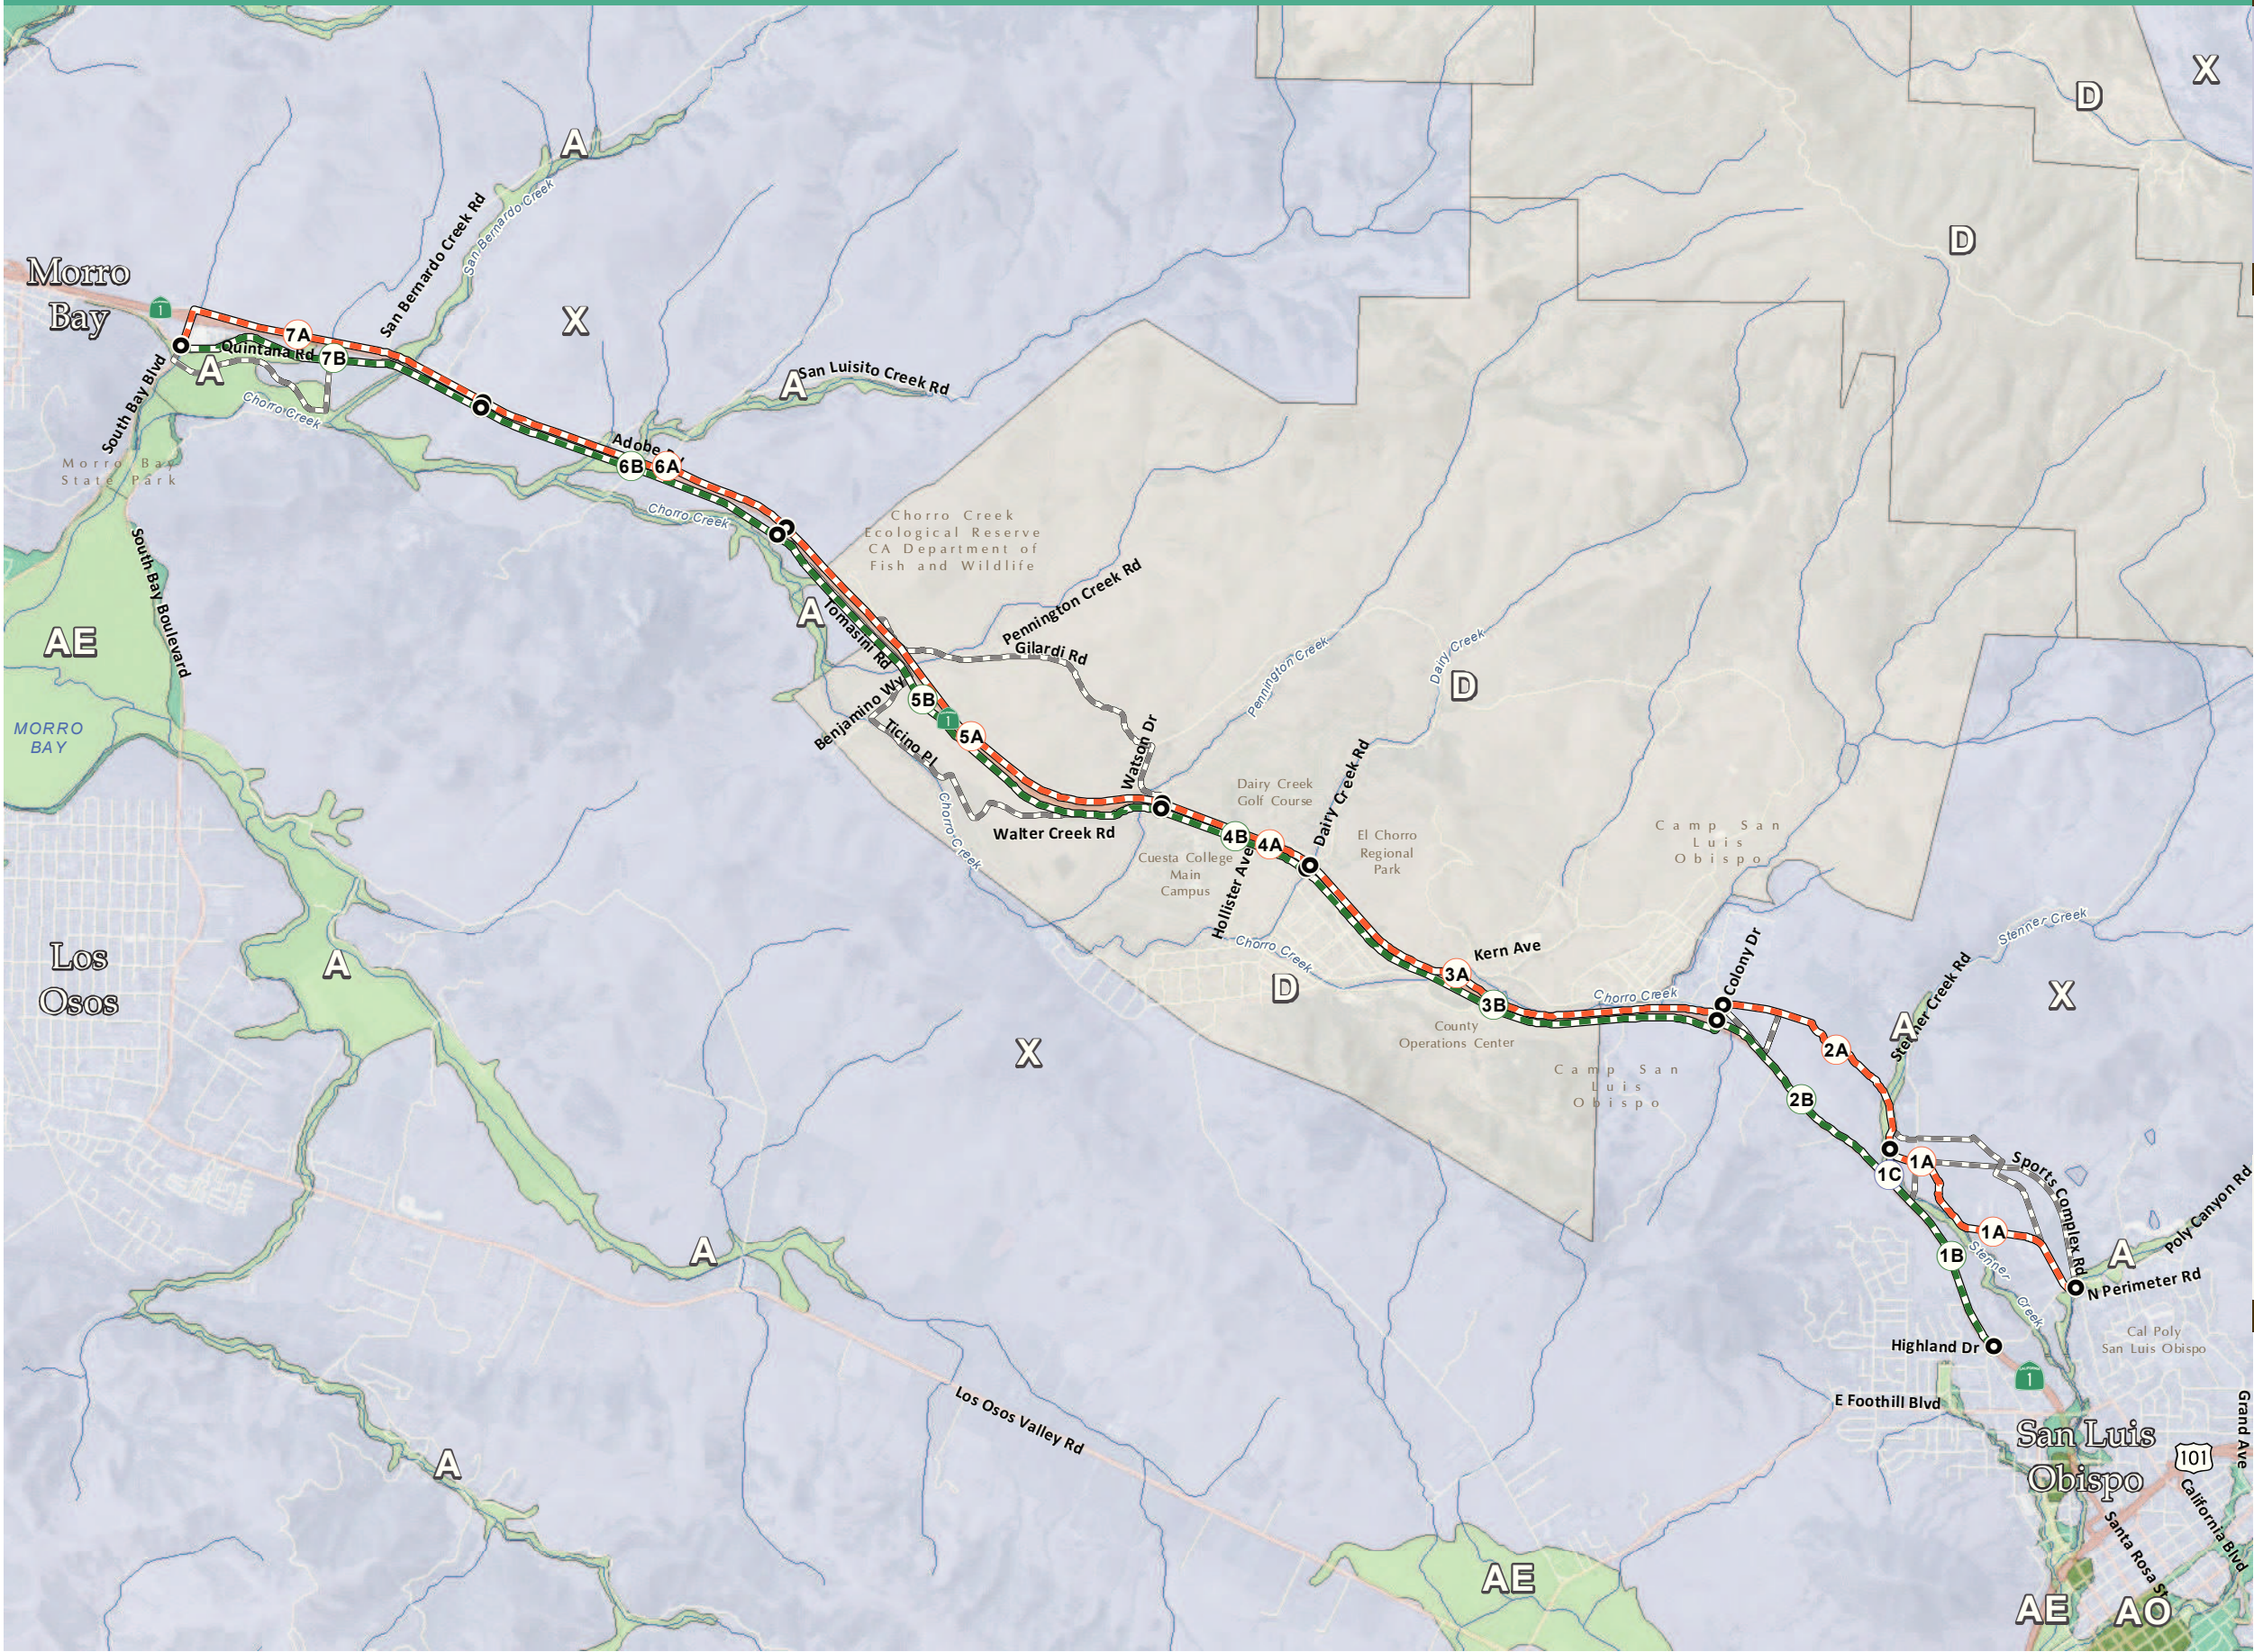
Trail Alignments FIGURE 5 FLOOD ZONES

The Federal Emergency Management Agency (FEMA) has prepared a series of maps that show flood hazards along Chorro Creek and many of the small tributary creeks in the study area (see Figure 5). According to FEMA's Flood Insurance Rate Maps (FIRM), much of the study area is located within a designated Zone X, indicating that this area has shallow flooding of less than one foot for the 100-year base flood, or is within the 500-year flood zone. The east half of the study area from around Gilardi Road east is in Flood Zone D, which is an area where flood zones are undetermined, but flooding is possible. In the western half of the Trail Study area, relatively narrow 100-year flood zones (Zone A) are shown along Chorro Creek, San Luisito Creek, and San Bernardo Creek. Zone A is defined as being subject to inundation by the 1-percent-annual-chance flood event. The floodzone broadens out along Chorro Creek in the vicinity of Chorro Flats.
